Mixmaster Rehabilitation NEWSLETTER

June 2022

Temporary Bridge Supports & Class S Repairs

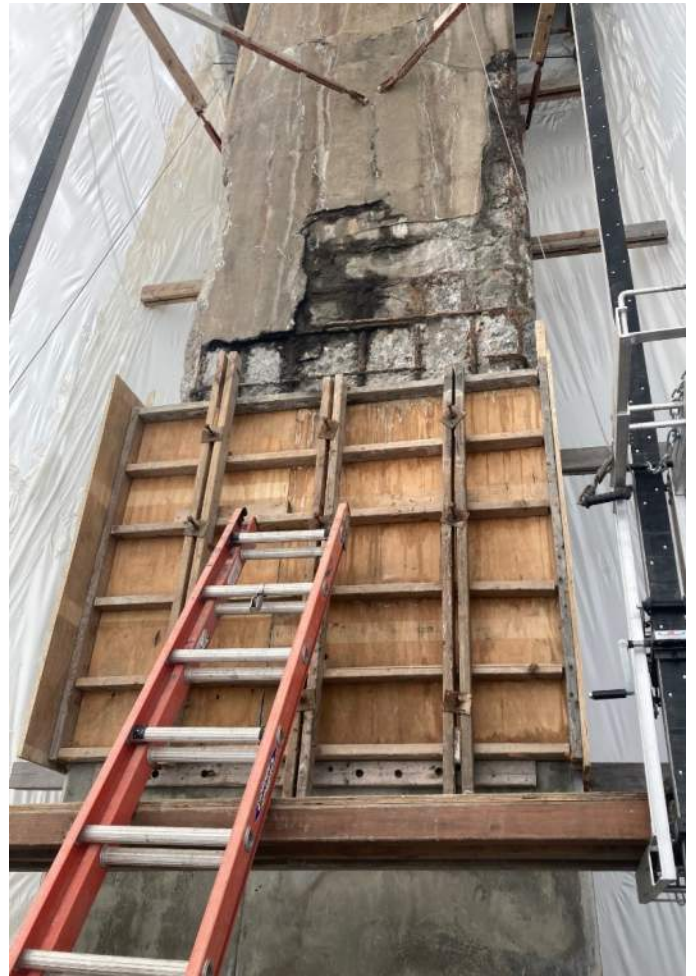
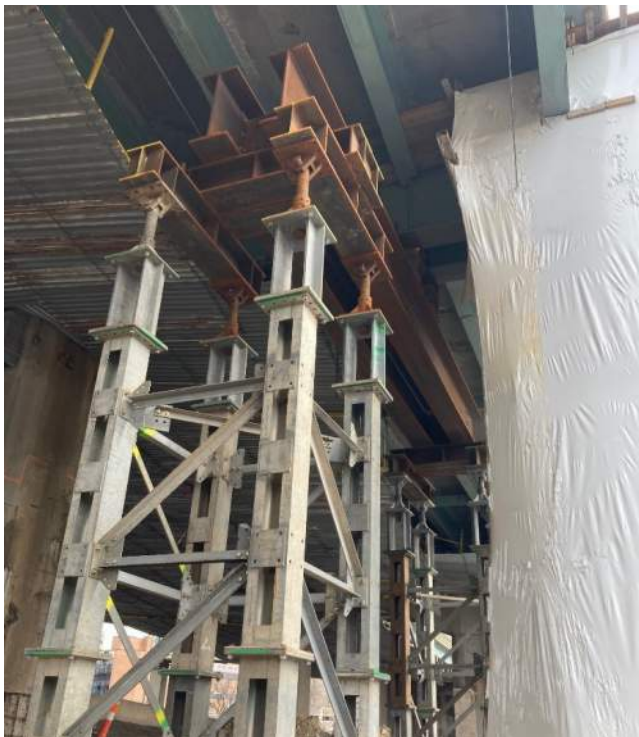
Like completing renovations on a vintage house, or restoring a classic car, rehabilitating a bridge can come with some surprises and may require some additional help or “support”. For the Route 8 / I-84 Mixmaster Rehabilitation project one of these unknowns that required a little extra help or “support” was related to the existing columns of the bridge. During the work, one of the activities required is an investigation of the concrete associated with the vertical columns that hold up the bridge. An inspector uses a hammer to tap the entire surface area of the columns. The sound that the hammer makes as it taps the different areas helps determine whether the existing concrete is sound and intact. A high-pitched ping of a sound means that the concrete is in good condition whereas a hollow thud of a sound, like a child’s plastic drum, identifies that a repair is necessary. As this process is completed, it only identifies the area of the repair and not necessarily the depth and overall extent of the repair. Once all areas are identified, the concrete is removed through small handheld pneumatic chipping hammers to a depth where sound concrete is found. The exposed reinforcement steel and concrete surfaces are then cleaned, and anti-corrosion devices are then installed within the network of reinforcement to help stretch the life of the steel. It is then formed to achieve an appropriate thickness of concrete over the existing reinforcement and new concrete is poured back in place.

These columns’ purpose is to support the structure and all traffic traveling over the bridge. As failure of a column could result in catastrophic failure of the bridge, the construction team needs to take great care and means to assure that during the repair process there are no chances of column failure. During the process of completing the concrete repairs, some of the repairs found were severe enough to require some temporary support of the bridge.

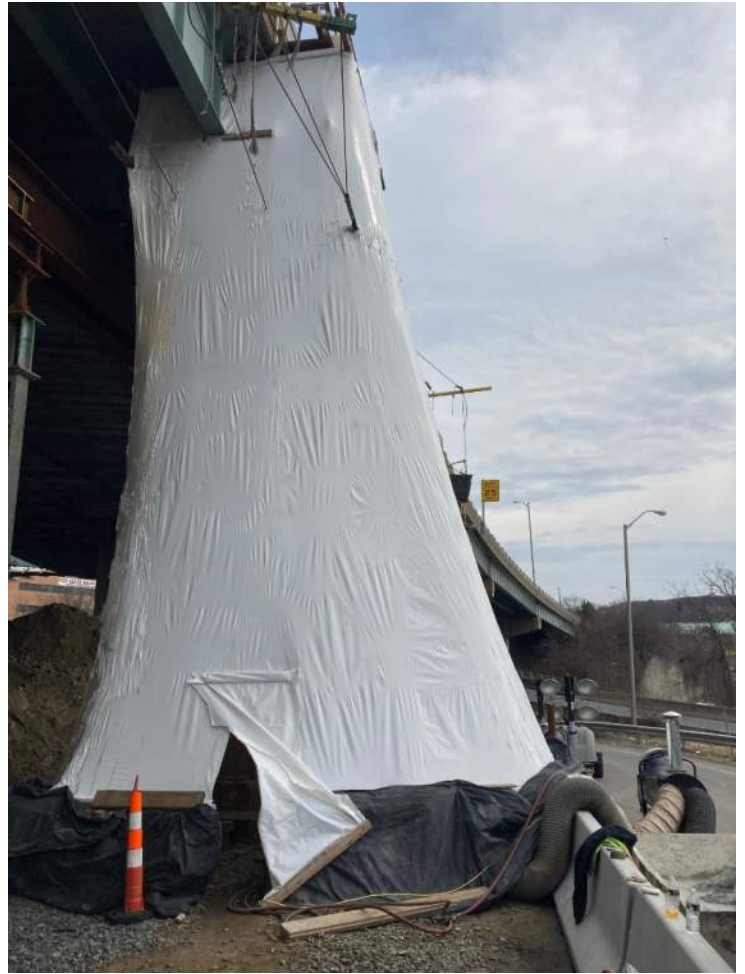
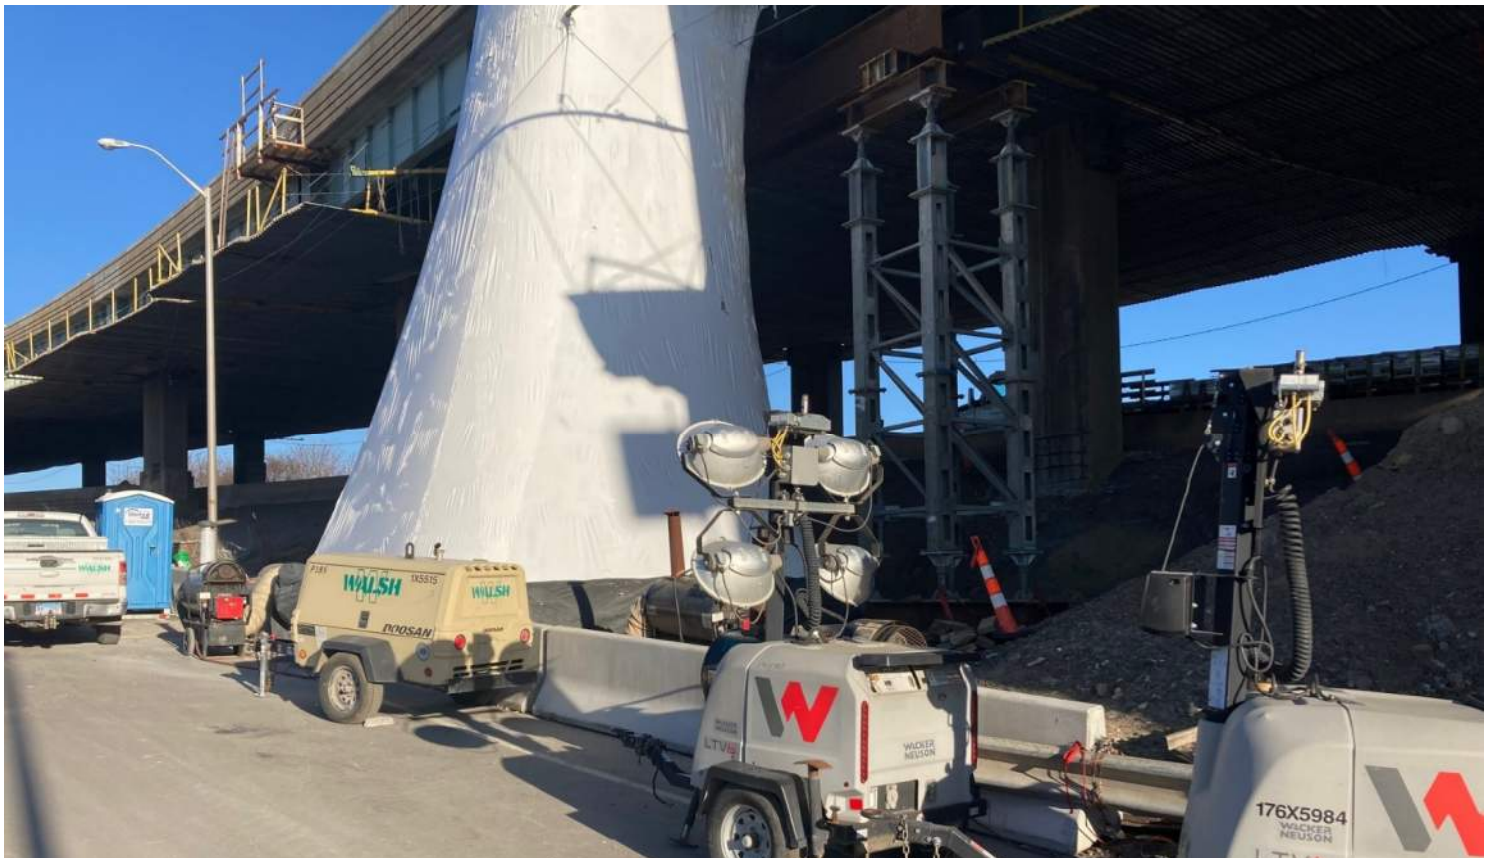
These temporary supports can be very large as they need to completely support the bridge to safely perform the repairs while allowing the bridge to stay in service. An example from this project where this was the case is on I-84 Westbound at Pier 42 on the Southern side of the bridge. This could be seen as you traveled on the I-84 Eastbound on-ramp from Meadow Street. Two large steel towers were constructed on wooden timber matting directly next to the existing concrete column which remained in place for several weeks. The column that needed the repairs was not visible for long at this point since it was encapsulated and heated to successfully complete the concrete repairs during the winter months. White plastic sheeting was wrapped around scaffolding and a wooden frame to contain the heat and give the contractor enough working space and access to complete the work. A series of heaters were kept running until the concrete reached a specific required strength. As the weather has become warmer and the chance of freezing weather is no longer a concern the enclosure has now been removed and the concrete repairs are on their way to completion.
