# Mixmaster Rehabilitation NEWSLETTER

October  
2020

Refurbishing Interstate 84

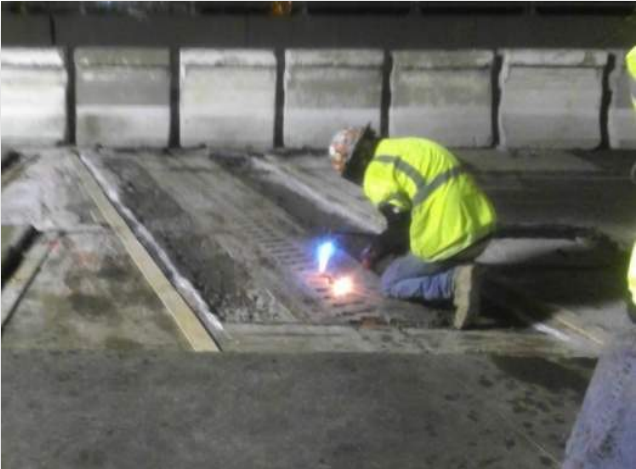
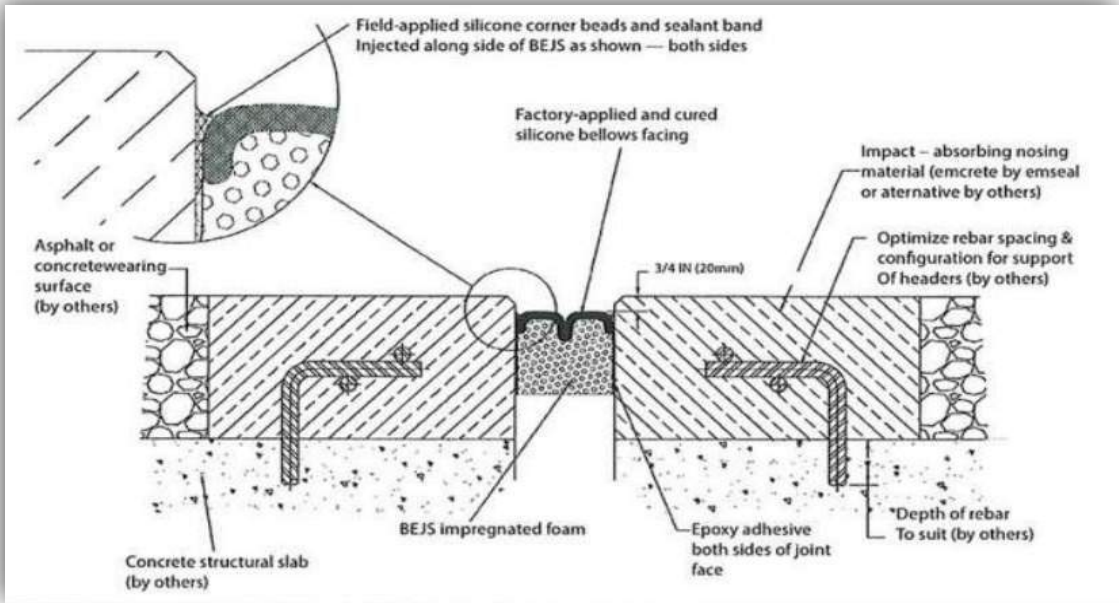
As shown in the illustration below, fitted between the deck-end headers is a preformed EMSEAL expansion joint. The joint seal will prevent water and road salts from coming in contact and deteriorating the structural steel and concrete substructure below. The foam-backed joint system has an "M" shaped silicone rubber top face. EMSEAL expansion joints are easier to repair and less expensive to maintain.

Today, with improvements in materials, most deck-end repairs within the Mixmaster group of bridges will utilize an Elastomeric Concrete Header with a preformed bonded rubber joint seal insert. Elastomeric Concrete is best described as a more flexible concrete comprised of a 2-part polyurethane material mixed with aggregates and water (traditional Portland Cement does not include polyurethane).
